SUNDAY RIVER WATERSHED ASSESSMENT AND PRELIMINARY RESTORATION STUDY

Final Report

Report No.: 2003-011
64 Pages, 6 Appendices

PREPARED BY
PARISH GEOMORPHIC LIMITED
AND
KLEINSCHMIDT

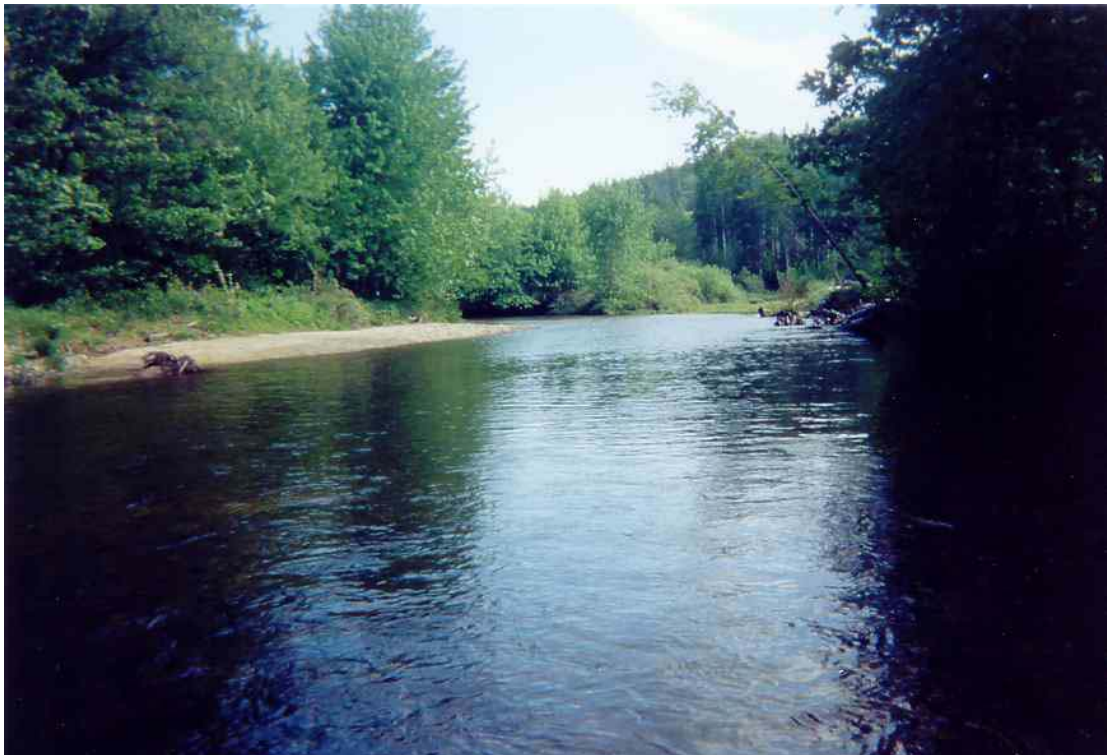
Reach SD-2. Monitoring site on the main channel near the Harrington property.

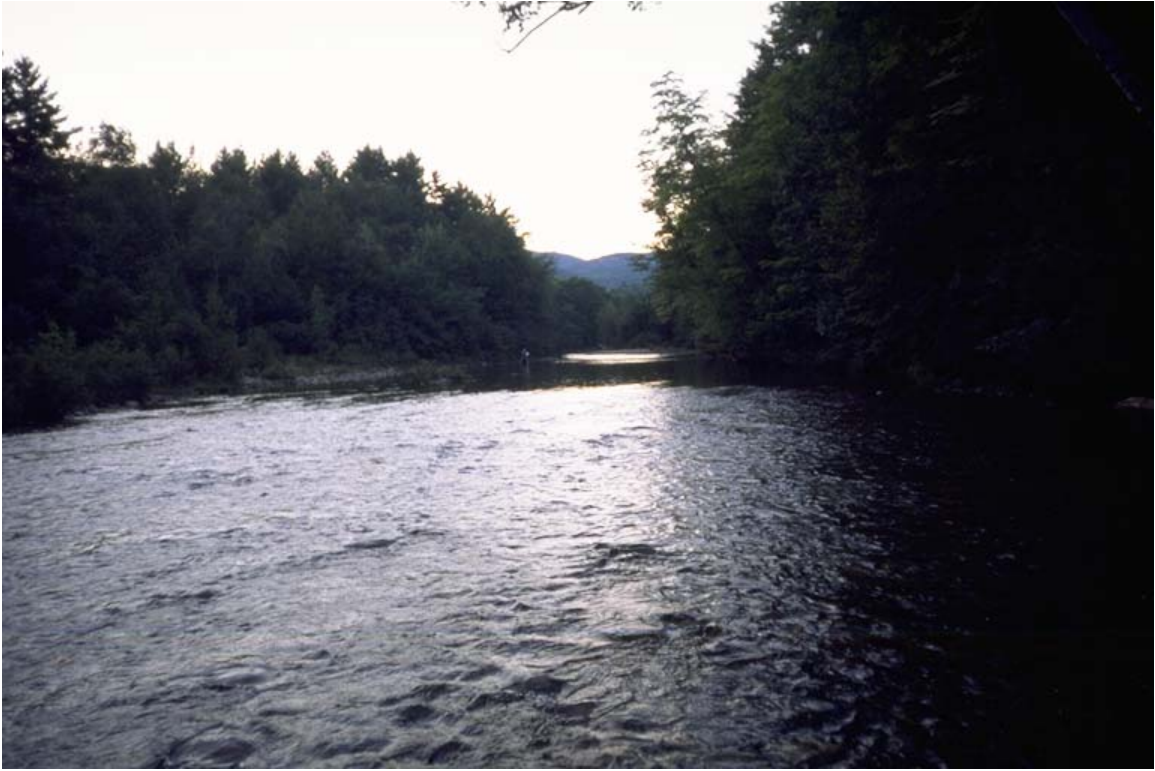
Reach SD-2. Main channel adjacent to snow making ponds.

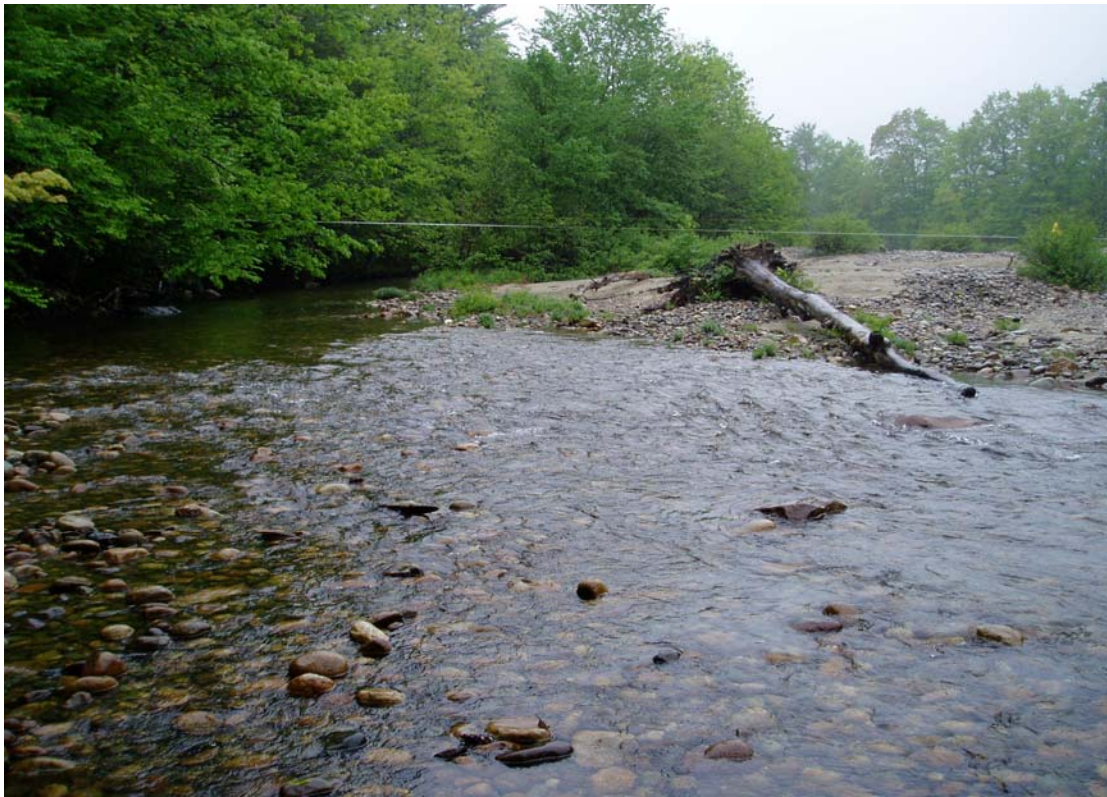
Reach SD-3. Right bank side of monitoring site upstream of covered bridge.

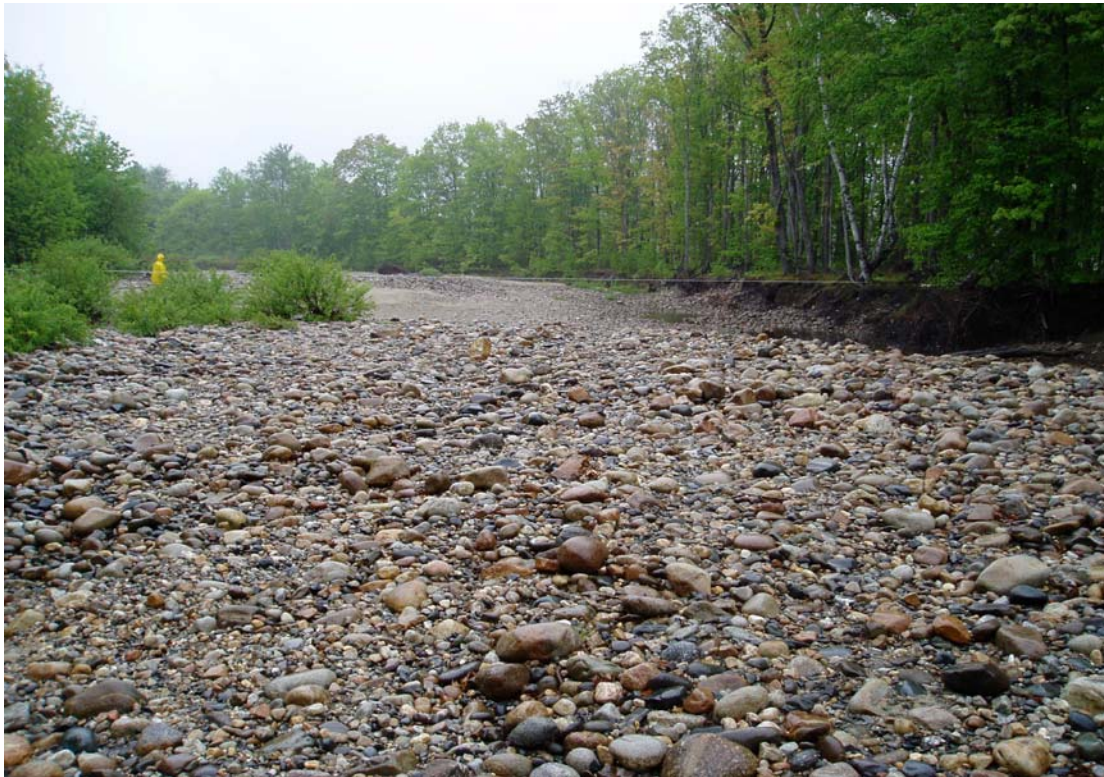
Reach SD-3. Left bank side (high flow channel) of monitoring site upstream of covered bridge.

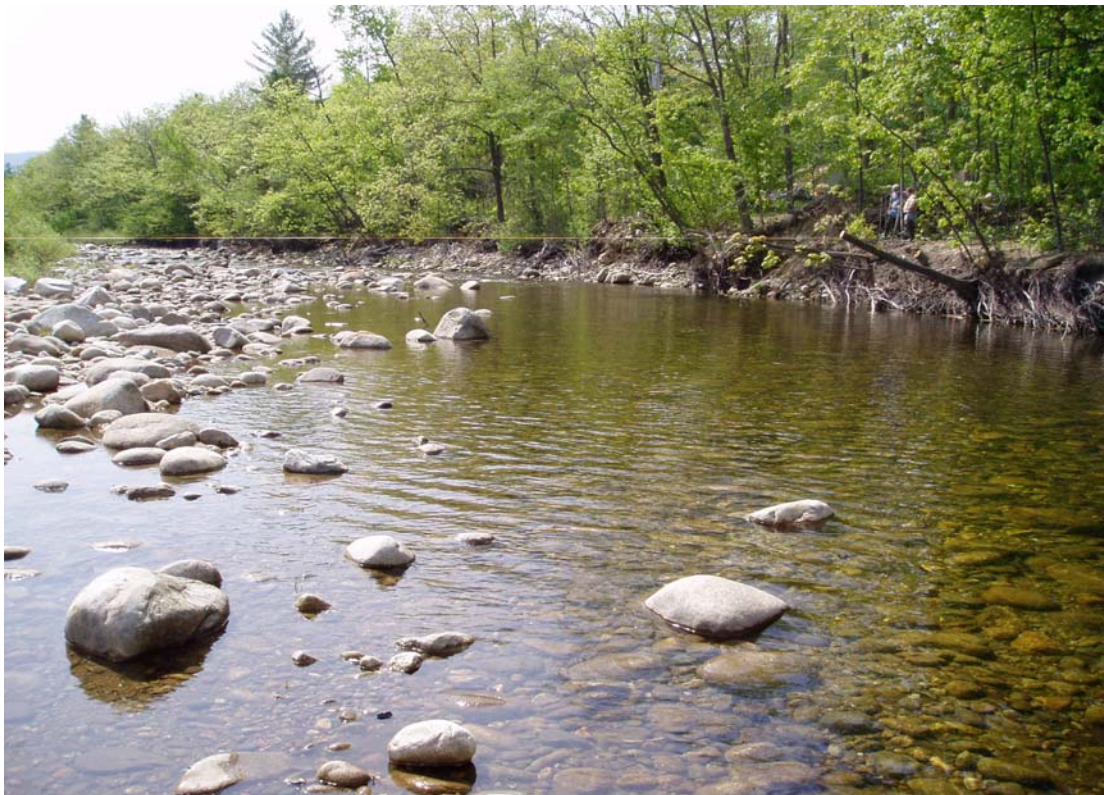
Reach SD-5. Monitoring site near the Outward Bound property. Note the extensive bank erosion of the downstream left bank.

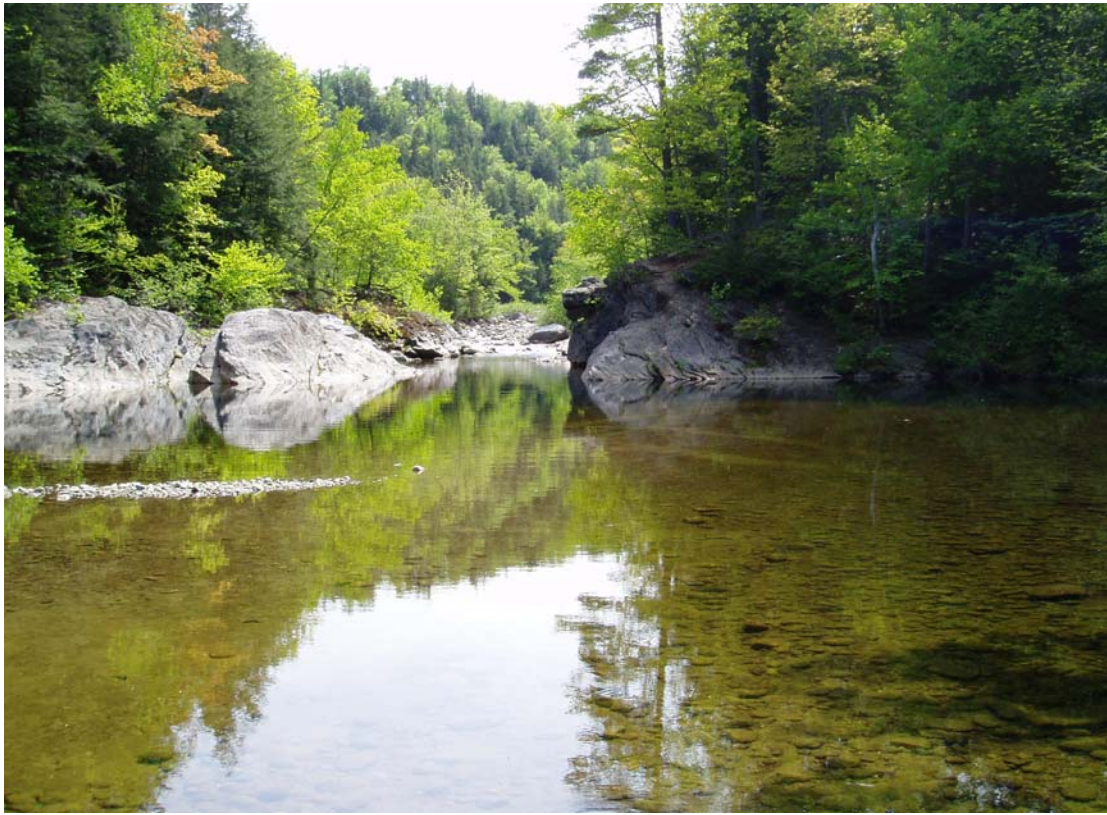
Reach SD-6. Large scour hole below bedrock outcropping area.

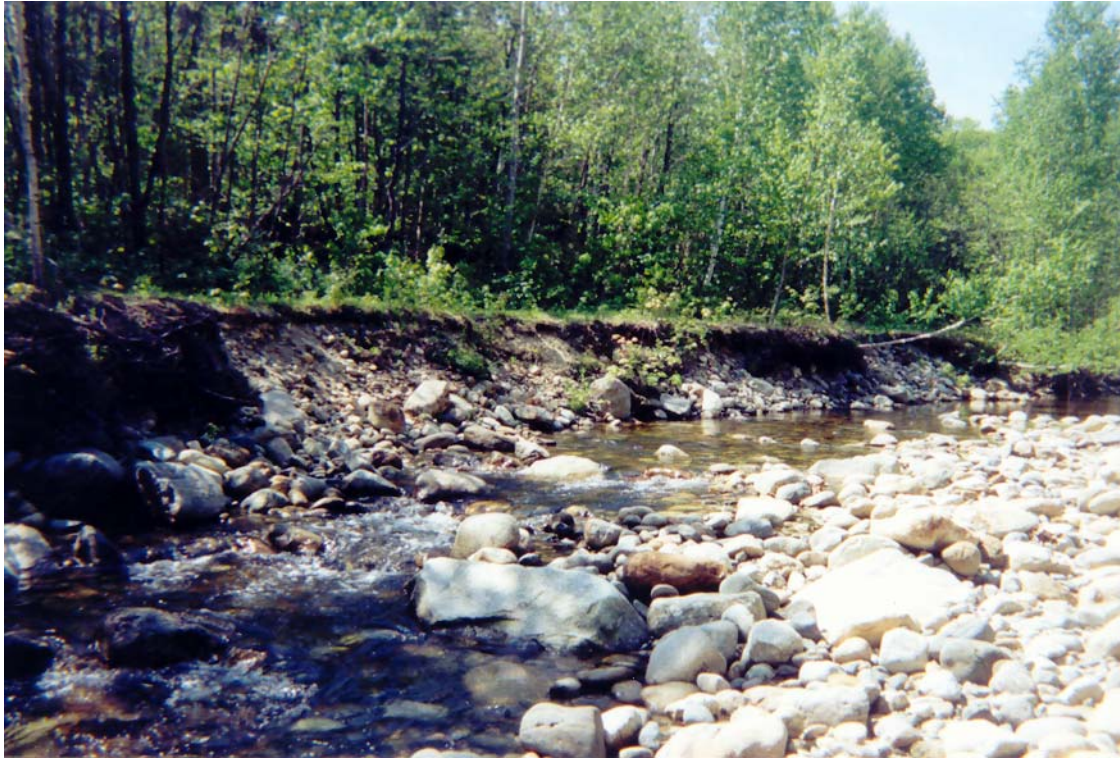
Reach SD-14. Below confluence of headwater tributaries on the South Branch. Note the major bank erosion and cobble/boulder deposits.

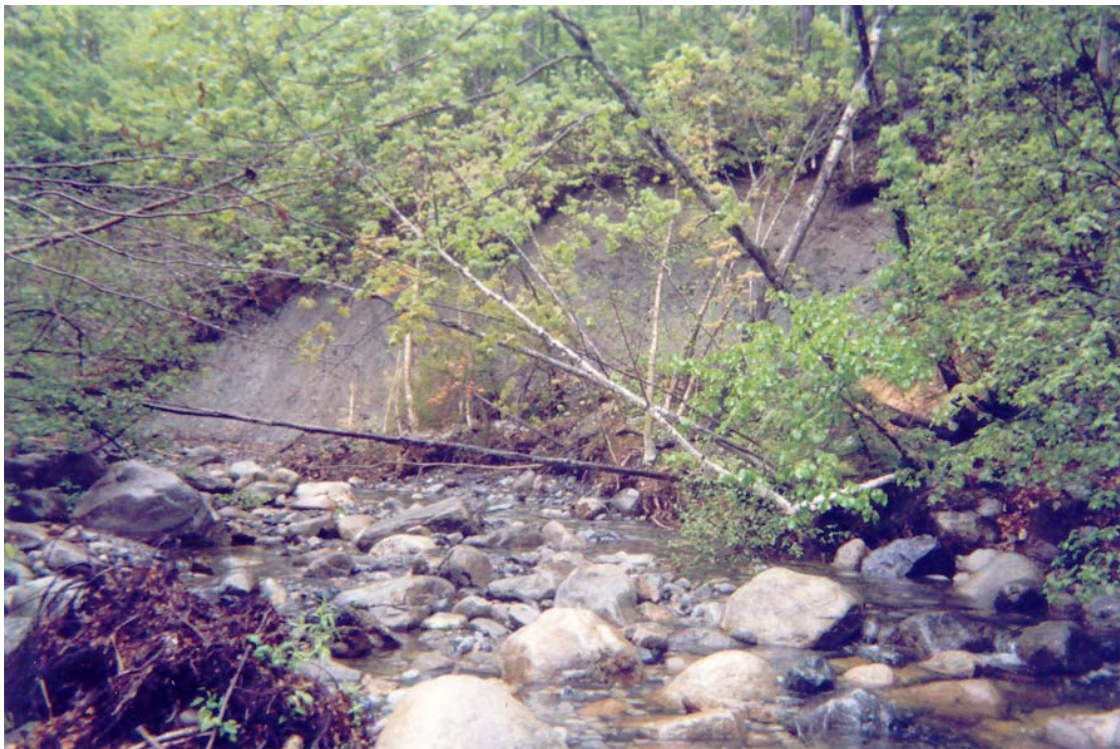
Reach SD-15. Large scarp in headwater tributary. Note large amount of wood debris and clumps of sediment associated with slope failure.

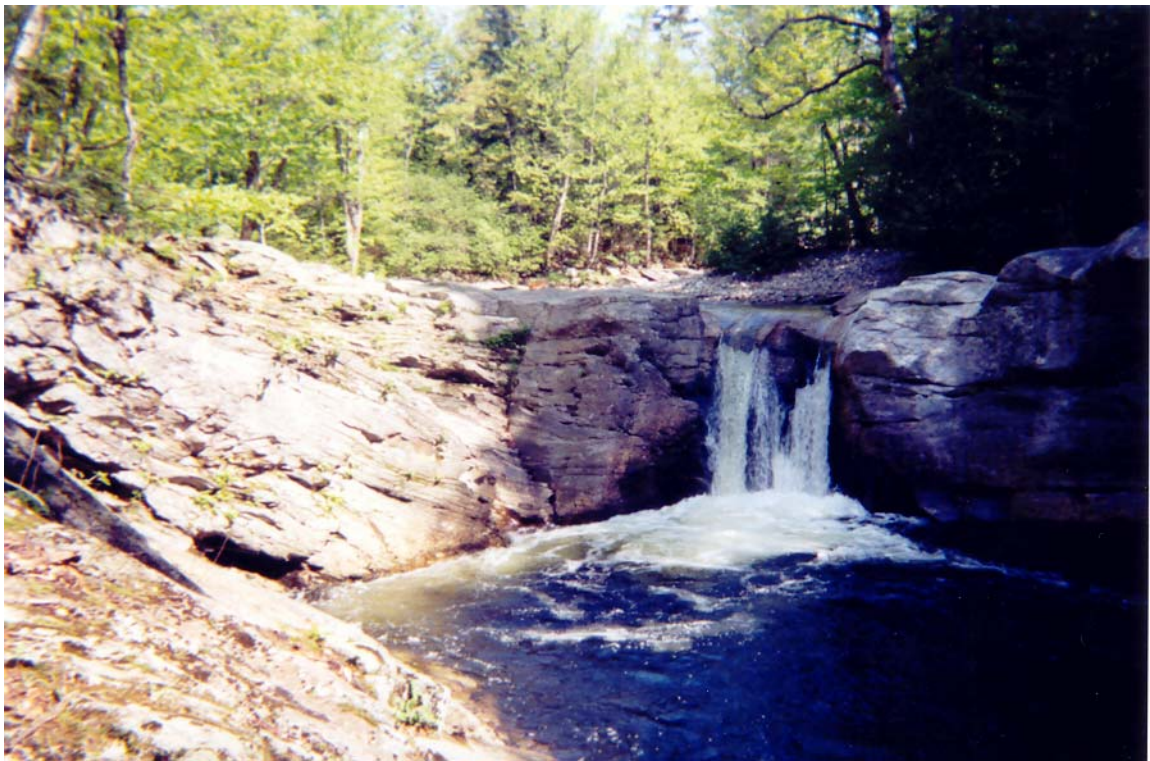
Reach SD-22a. Bedrock knick-point above large scour hole on the Bull Branch.

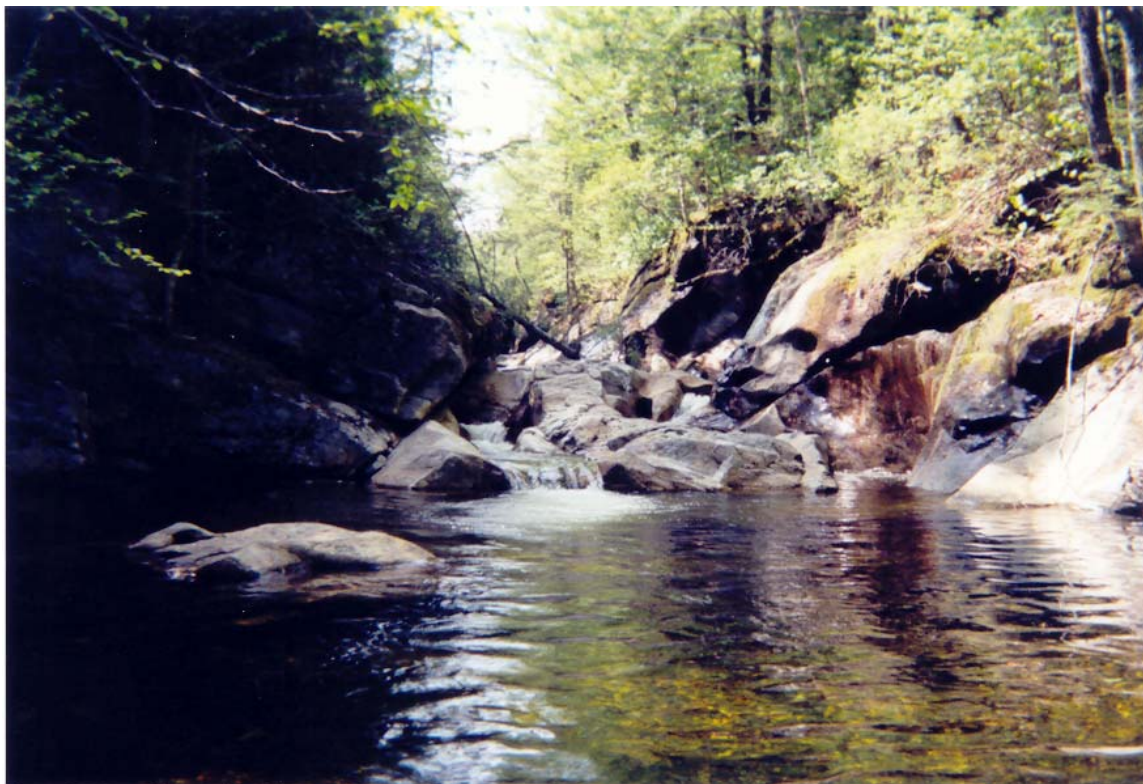
Reach SD-24. Downstream end of narrowed 'canyon' area. Note large scour hole in foreground of photo.

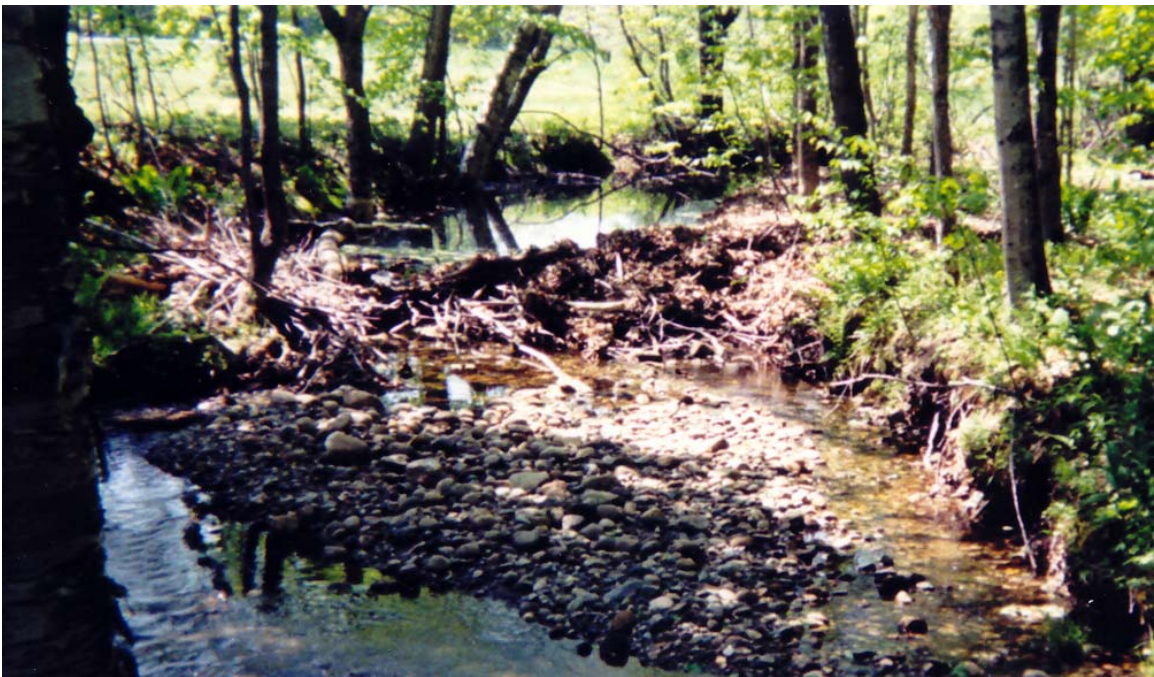
Reach SD-31. Simons Brook. Note the basal scour of the banks and the moderately dense ground cover in this forested area.

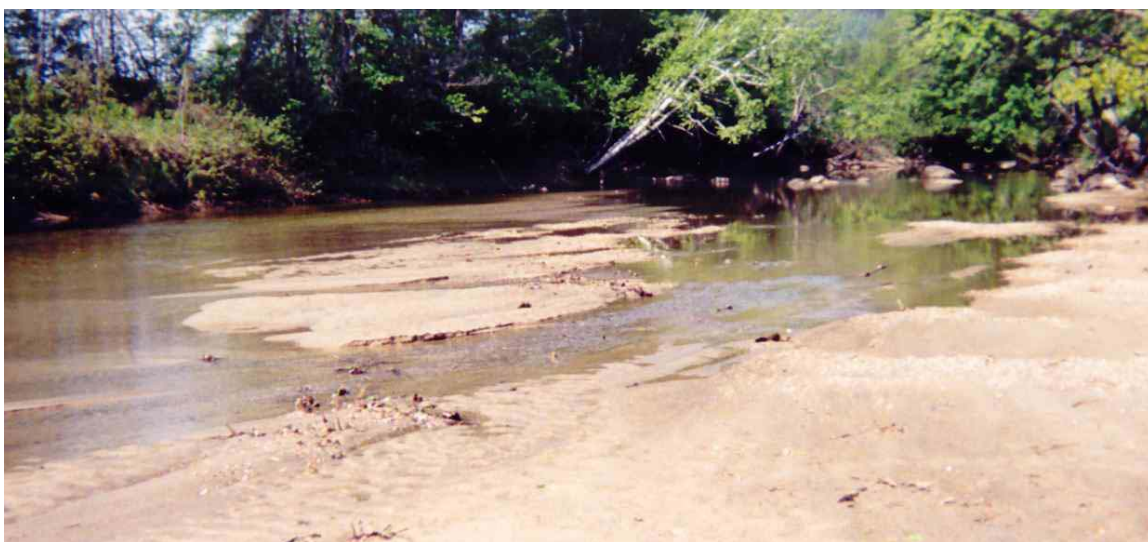
Photo 2. Area of deposition in Reach SD-2.

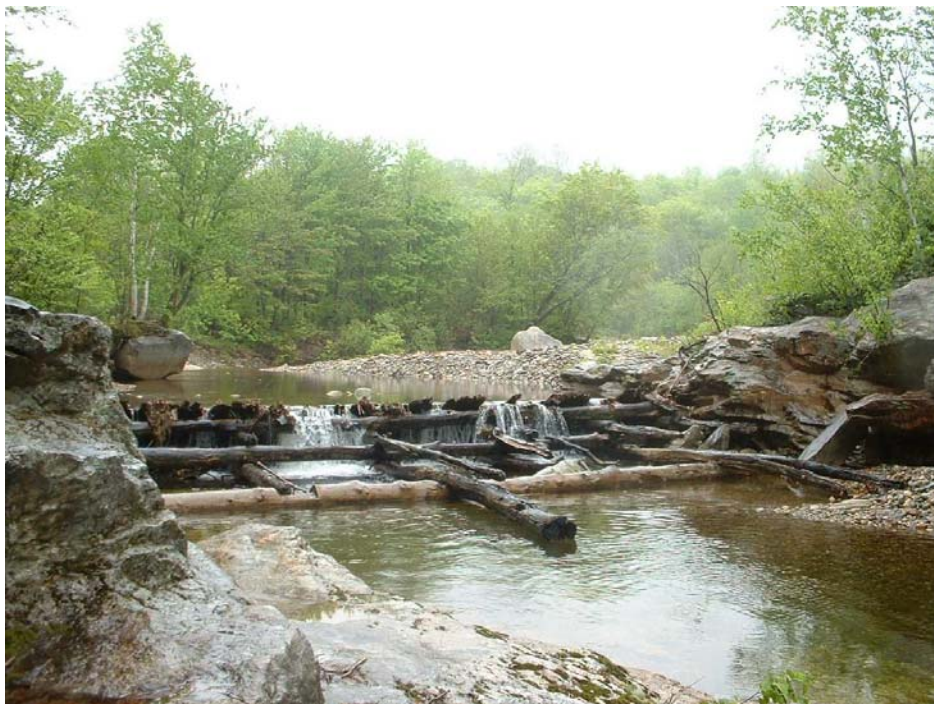
Photo 1. Old timber dam observed during field reconnaissance.

Figure 1. Proposed Rocky Ramp / Riffle Structure channel works to replace existing timber dam.

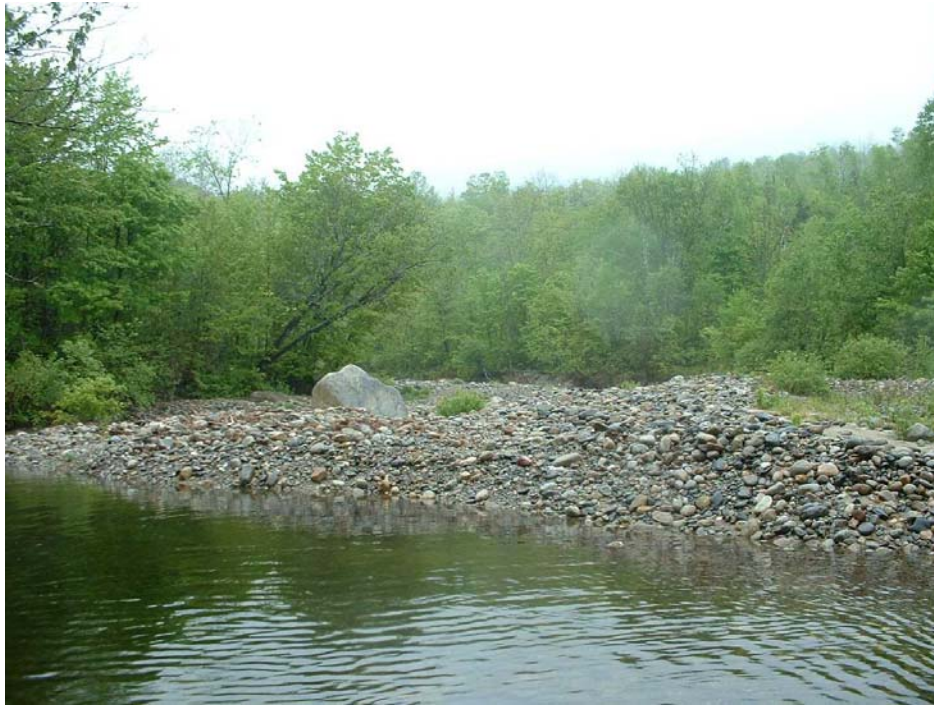
Photo 2. Extensive bar that has formed upstream of the timber dam structure.

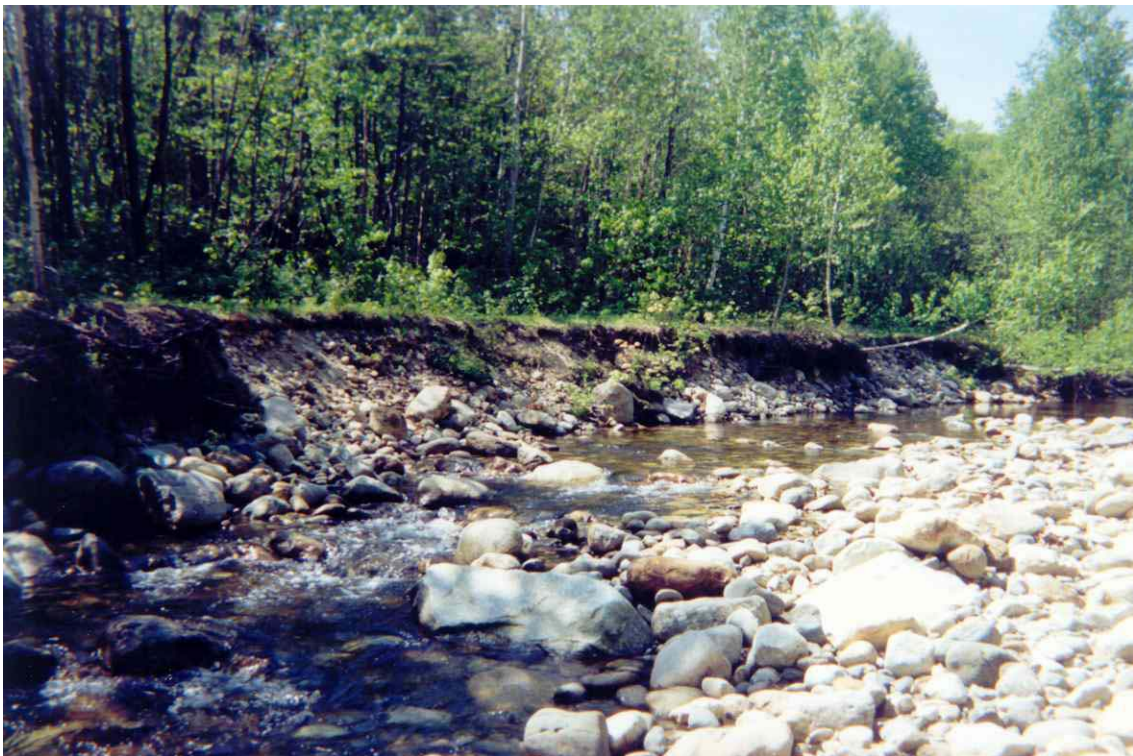
Photo 1. Severe bank erosion and cobble deposit typical of conditions observed in Reach SD-14 during the rapid assessment.

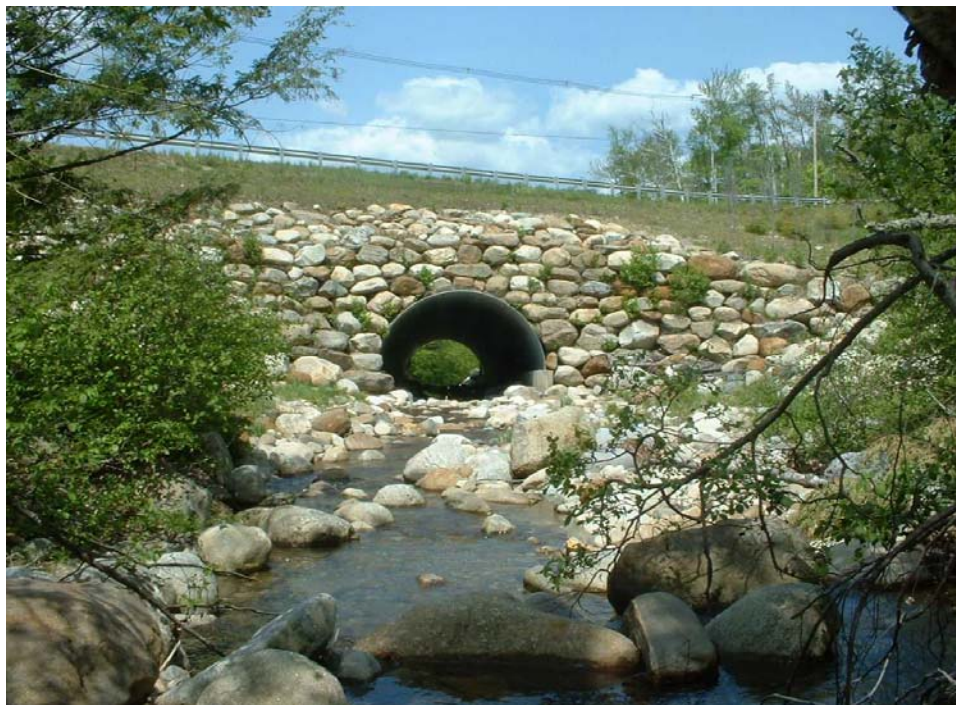
Photo 1. Downstream end of Merrill Brook Culvert.
